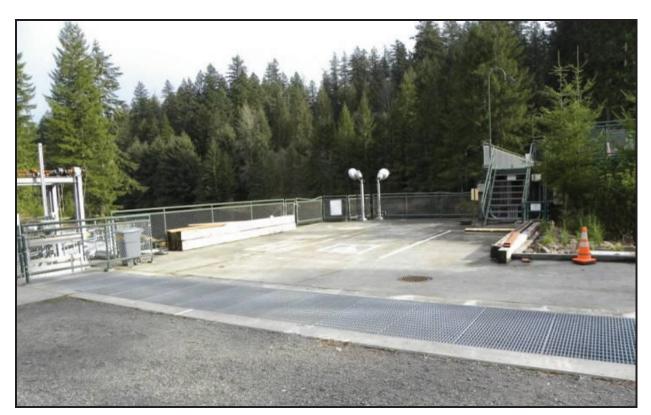
Parking at the site is predominantly unstructured. This often results in a haphazard scattering of vehicles. particularly when visitors are present. It can also cause maneuvering problems for delivery trucks. Some striped parking spots, including a designated ADA space (see Photo 3-2), are available adjacent to the dam. Informal parking areas are around the green garage (see Photo 3-3) and on the north side of the treatment building. Parking is particularly troublesome when flood events occur, as additional staff and possibly a logging crew come to the site to prevent buildup of waterborne debris against the dam.

Photo 3-2. ADA Parking at the Dam

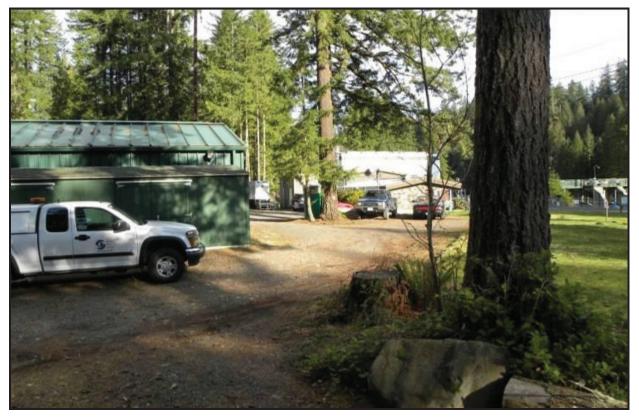
- Insufficient turning/maneuvering space for chemical delivery trucks
- Difficult exiting for chlorine delivery trucks around tight turn and relatively steep grade at driveway north of treatment building
- Use of Park Road for exiting by delivery trucks requires manual gate operation
- Load/unload at green garage causes blocking
- Circulation around green garage area awkward, particularly with non-structured parking.

Photo 3-3. Unstructured Parking Near Green Garage

- Paving at drives, particularly on slopes
- Drive turns should be constructed to meet delivery truck turning radii
- Structure parking and delivery to prevent blocking
- Configure circulation to eliminate use of Park Road gate at the dam/treatment site
- Signs at 9 Road driveway and at parking areas.
